**Flood Control Project Maintenance
Levee Inspections**

Fall 2010 Levee Maintenance Deficiency Summary Report

Sutter Maintenance Yard Maintenance Area 0005

Levee Inspection Report By Mile - Fall 2010

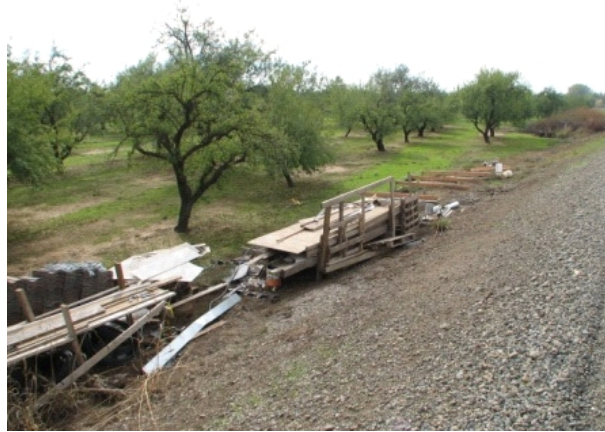
Levee Mile Report Line	3
Start Levee Mile	1.68
End Levee Mile	1.68
Location	Land Side
Category	Earthen Levee
Item	Encroachments

View of the removed garbage but construction supply on pallets.

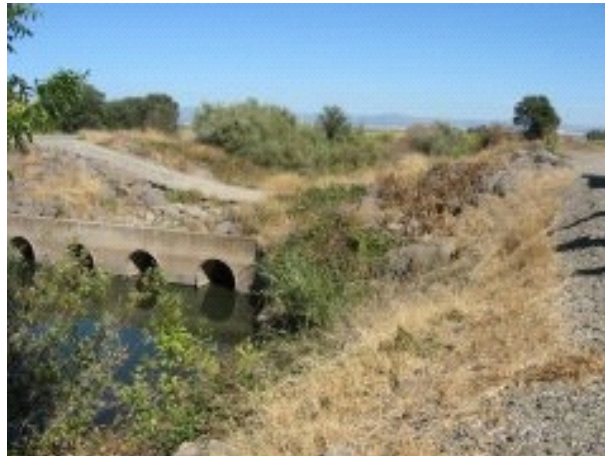
Levee Mile Report Line	14
Start Levee Mile	9.66
End Levee Mile	9.69
Location	Water Side
Category	Supplemental
Item	USACE Erosion Survey

13	3.48	3.48	Earthen Levee	Encroachments	LS	C	Prunings	39.652020 ° -121.789337 °	39.652020 ° -121.789337 °	905
14	9.66	9.69	Supplemental	USACE Erosion Survey	WS	U	Inspector Comments: 2009: no berm, vertical slope, no stability issues, sands and silts, 3.5 ft/s plus eddy currents [2009 SiteID:BTC_9-6_L]	39.574908 ° -121.807800 °	39.574875 ° -121.808108 °	7 Y

2009: no berm, vertical slope, no stability issues, sands and silts, 3.5 ft/s plus eddy currents [2009 SiteID:BTC_9-6_L]

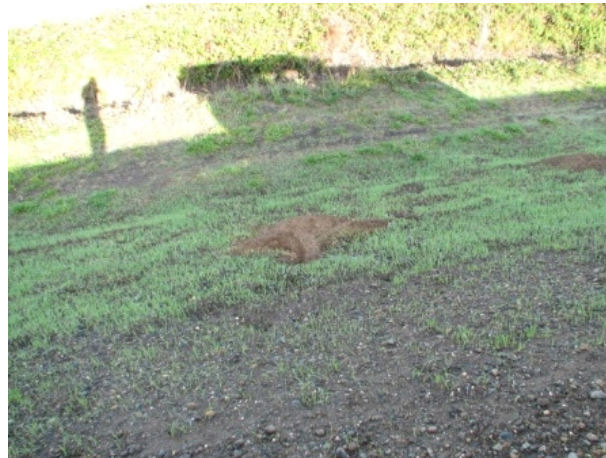
Levee Mile Report Line	3
Start Levee Mile	4.86
End Levee Mile	4.86
Location	Land Side
Category	Earthen Levee
Item	Animal Control

View of the squirrel hole on the slope.

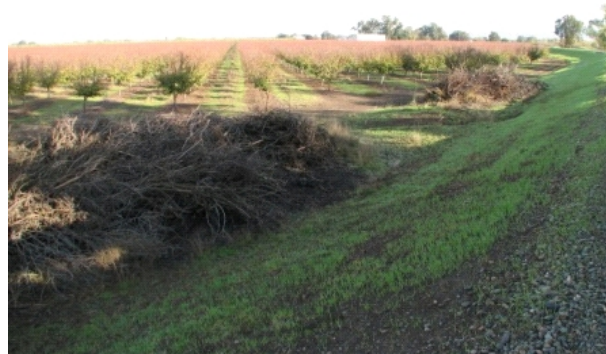
Levee Mile Report Line	5
Start Levee Mile	7.86
End Levee Mile	7.86
Location	Land Side
Category	Earthen Levee
Item	Encroachments

View of the debris and garbage along the landside toe of the levee.

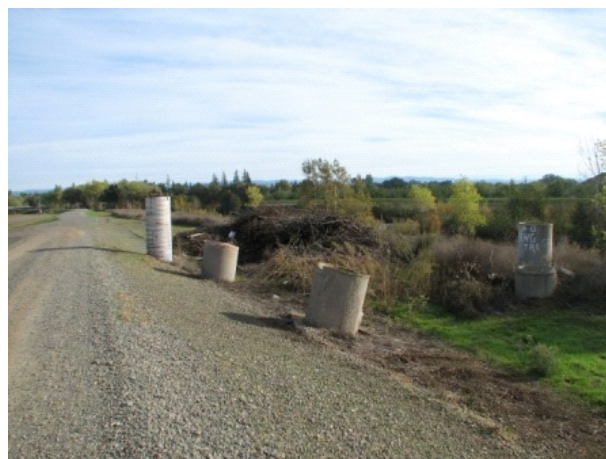
Levee Mile Report Line	14
Start Levee Mile	13.35
End Levee Mile	13.35
Location	Land Side
Category	Earthen Levee
Item	Encroachments

View of prunings and garbage along the toe.

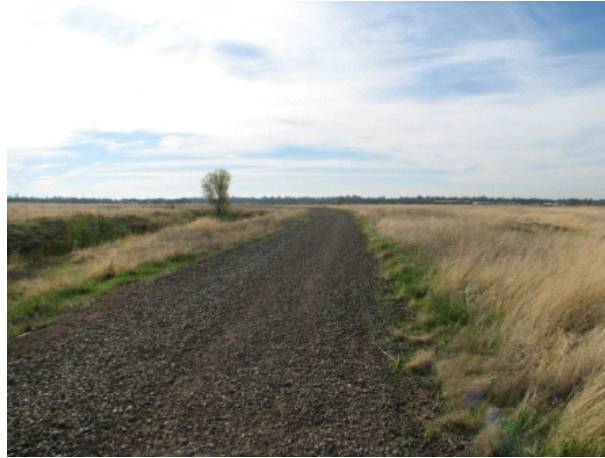
Levee Mile Report Line	1
Start Levee Mile	0.71
End Levee Mile	0.71
Location	Crown
Category	Earthen Levee
Item	Crown Surface / Depressions / Rutting
View of crown roadway clear of vegetation.	
rduffey_f_20101115_300.jpg

LMR No.	Levee Mile		Category	Item	* Location	** Rating	Action/Comment	GPS Latitude/Longitude		Issue No.
	Start	End						Start	End	Photo
1	0.71	0.71	Earthen Levee	Crown Surface / Depressions / Rutting	CR	A	Keep the crown roadway free of vegetation.	39.726058 ° -121.781487 °	39.726058 ° -121.781487 °	3 Y
